National Transportation Safety Board

RRD22LR008 - BOSTON, MASSACHUSETTS

MECHANICAL

Factual Report

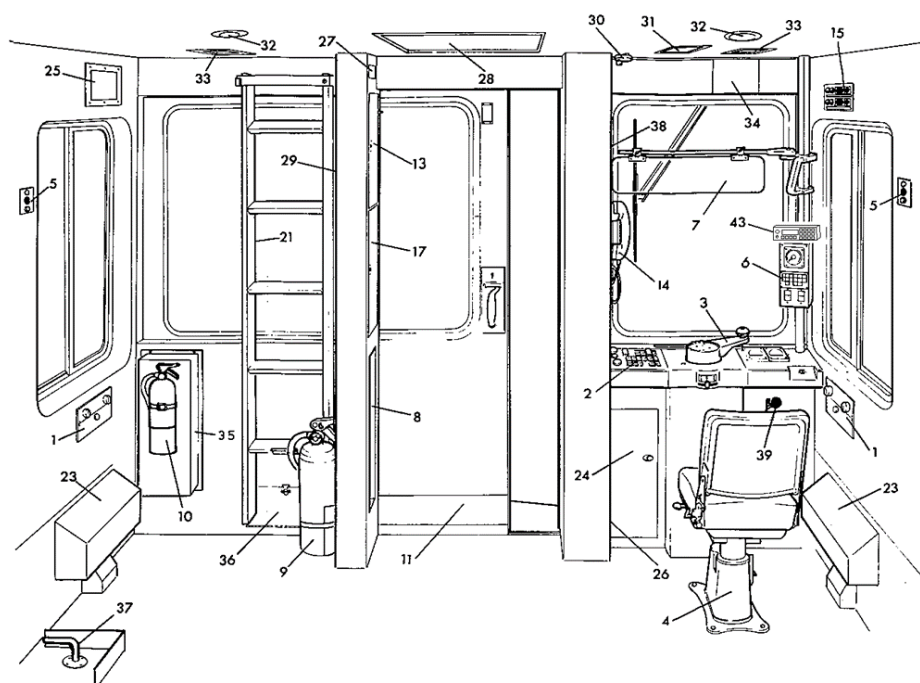
Figure 1. Train Operator Cab Diagram

18 The train operator compartment was located at the number 1 (cab) end of each
19 railcar, adjacent to and connected with the passenger compartment. A cab fitted at the
20 end of the car allowed the car to be operated (controlled) from either end, and allowed
21 the multiple unit cars to operate bi-directionally (i.e., the car/train could be operated
22 in a reverse direction without having to physically reverse the direction that the car was
23 facing). The train operator compartment, which extended the width of the car, was a
24 dedicated workspace for use by the train operator, and consisted of an operator's seat,
25 a control panel (containing the car / train operating control features, and car / train
26 condition instrumentation / monitoring equipment). A glass windshield was provided
27 at the end of the car (that allowed the operator a view of the area in front of a car /
28 train). A door was provided in the partition, which afforded access to the train

29 operator's compartment from the passenger compartment. The train operator also had
30 access to a cab end door which afforded access to the front exterior of the railcar (see
31 Figure 1).

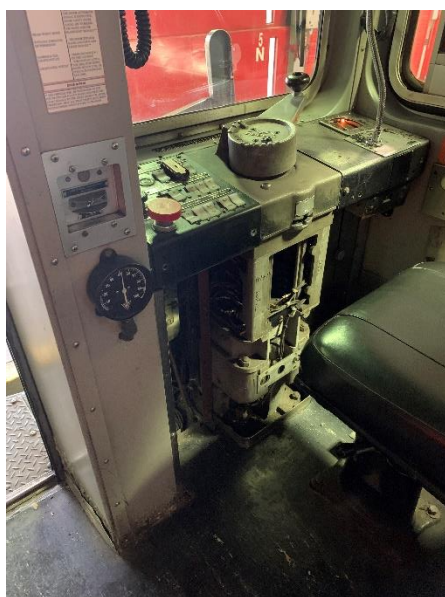
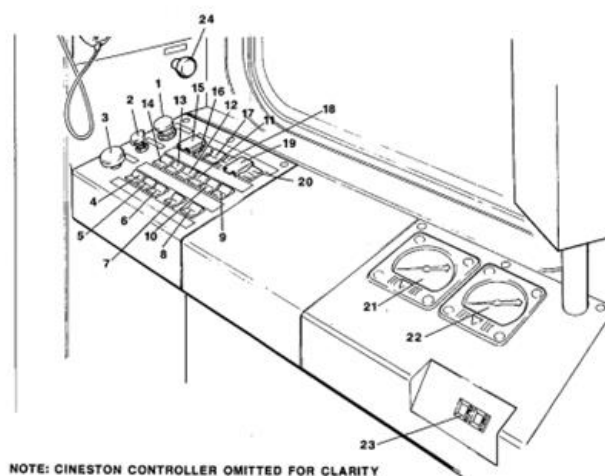
Figure 2. Car 1511 - Operator Control Console

1 Located adjacent to the master-controller handle on the train operator console
2 were the horn, car lights, headlights and other railcar control buttons. An automatic
3 door starting signal button was also located on the control console. When depressed
4 by the train operator, the automatic door starting signal button would sound a buzzer
5 if the passenger service doors on all railcars were in the closed position (see Figure 2).

10 Postaccident testing determined the automatic door starting signal button when
11 depressed, would only produce an audible signal when all passenger service doors
12 were completely closed, and no obstructions were detected by the system that would
13 cause the doors to recycle. Testing determined the automatic door starting signal
14 button would not buzz if a passenger service door was open, obstructed or recycling.
